**Request for Expression of Interest  
(RFEOI) to Develop and Operate a  
Fueling Facility and Commercial Pier at  
the Fisherman's Wharf, Victoria BC.**

**RFEOI # 2020– 28013**

Summary Facility Condition Report 2019 – Huron Pier

## Huron Street Pier Condition Assessment Report

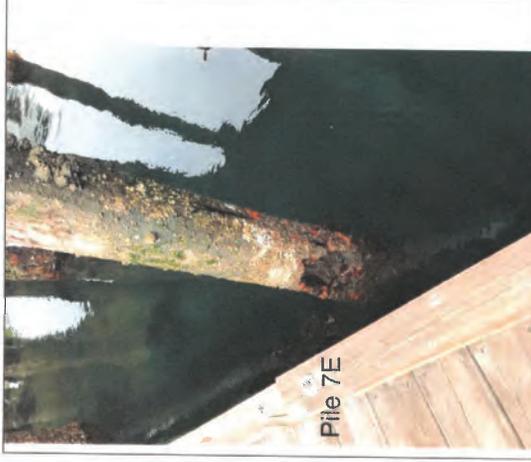
The piles are in variable condition. As described below, some piles have suffered from extensive marine borer attack (See Photo 2, Appendix A-1) and are now effectively 'hollow' (noted as "severely damaged piles"). Other piles ("notable piles") have some form of surface deterioration which is now compromising the long-term durability of the timber. Typical examples of the surface deterioration include checking, bolt holes, and mechanical damage (See Photo 3). The location of the severely damaged piles and noted piles have been provided in the damage drawing and damage table (see Appendix B – Damage Drawings and Appendix C – Inventory of Structural Damage).

<p>Pile 7E</p>	<p>Photo 2 – View of approach pile at gridlines 7 &amp; E. This provides a typical example of a pile suffering from extensive marine borer attack.</p>

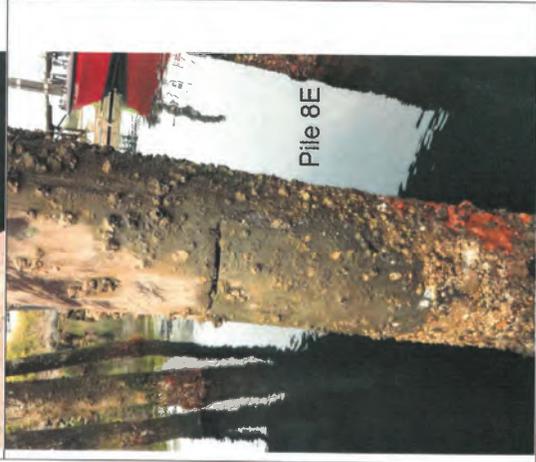
<p>Pile 8E</p>	<p>Photo 3 – View of approach pile at gridlines 8 &amp; E. This provides a typical example of a pile which has suffered mechanical damage which may make the pile susceptible to future deterioration.</p>

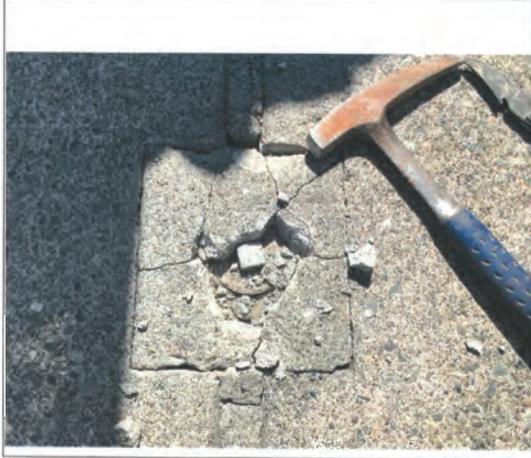
The concrete deck is in serviceable condition. Little to no deterioration was noted on the individual concrete members. The grout between the panels however is generally deteriorated, cracking or missing (See Photo 4 & 5). These should be sealed as these joints provide some level of protection from the ingress of water to the pile caps below.

<p>Photo 4 – View of typical grout deterioration in joints between precast panels.</p>

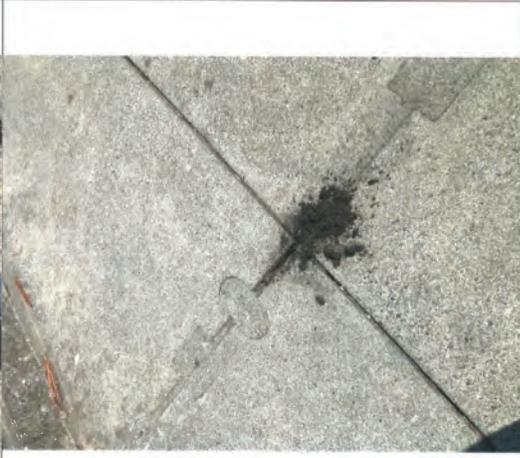
<p>Photo 5 – View of typical grout deterioration in joints between precast panels. Note: at the time of the inspection, the joint was full of dirt and debris (black substance in the image).</p>

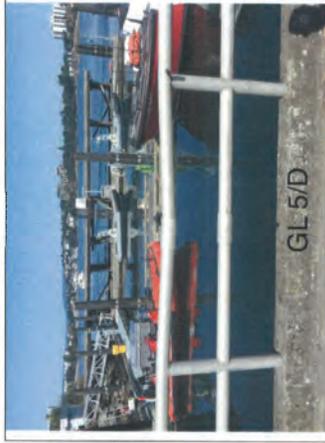
The handrails and curbs are generally in good condition. At one location on the west side of the approach, from gridlines 4D to 6D a portion of the handrail is deformed likely due to an impact. Welds on 3 of the posts have failed (See Photos 6 & 7). This section of handrail requires repair.

<p>Photo 6 – View of deflected approach handrail near gridlines 5 &amp; D.</p>

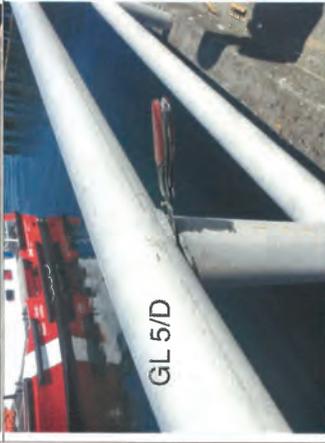
<p>Photo 7 – Close view of deflected approach handrail near gridlines 5 &amp; D showing failed weld connection.</p>

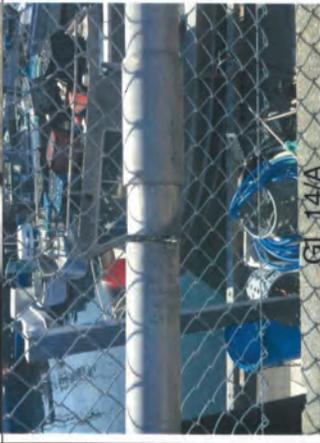
<p>Photo 8 – Close view of approach handrail near gridlines 14 &amp; A showing a displaced handrail sleeve connection.</p>

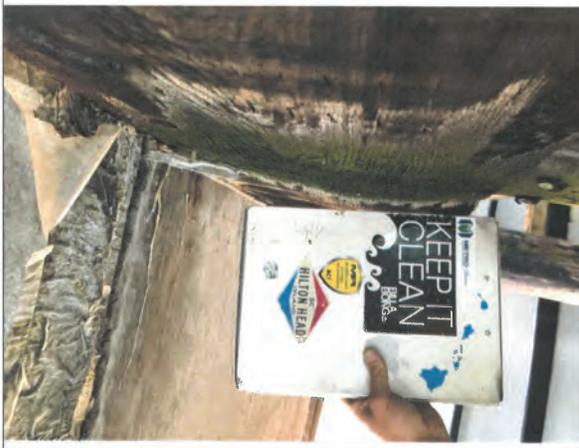
There are two distinct groups of pile caps: the old ones and the newly replaced ones (reportedly replaced in 2019). The newly replaced are in good condition. All of the old pile caps are suffering from extensive fungal decay and can no longer be depended on for sustaining a live load. These require replacement.

Photo 9 – View of a pile cap side near on the wharf head near gridlines 4 & K. The pile cap has experienced 'bulging' due to the deteriorated condition of the pile cap interior.

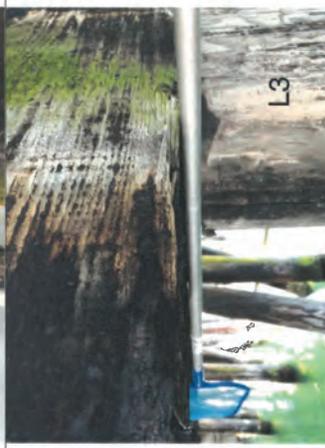
Photo 10 – View of a pile cap soffit near on the wharf head near gridlines 3 & L. The pile cap has experienced 'crushing' due to the deteriorated condition of the pile cap interior.

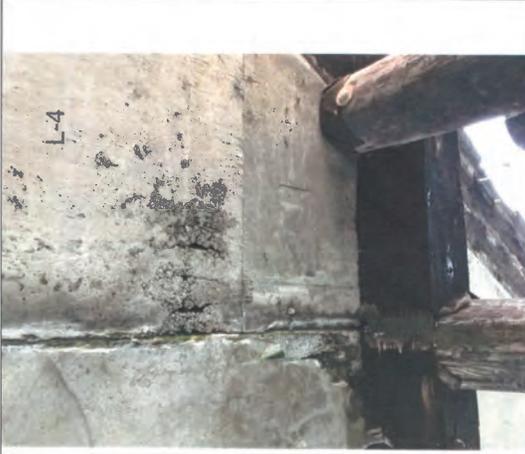
<p>L-4</p>	<p>Photo 11 – View of the concrete deck soffit on the wharf head near gridline 4 &amp; L. Concrete honeycombing and exposed reinforcing steel is noted.</p>

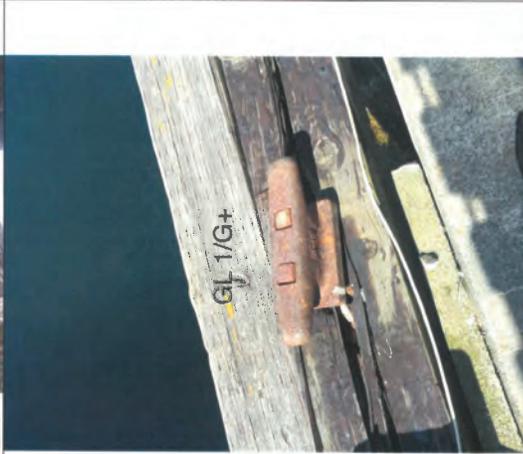
<p>GL 1/G+</p>	<p>Photo 12 – View of cleat currently supported by extensively deteriorated timber member.</p>

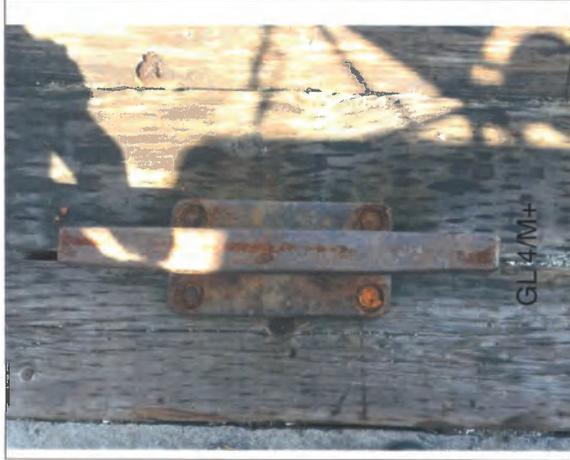
<p>Photo 13 – View of cleat with extensive corrosion present on fasteners.</p>

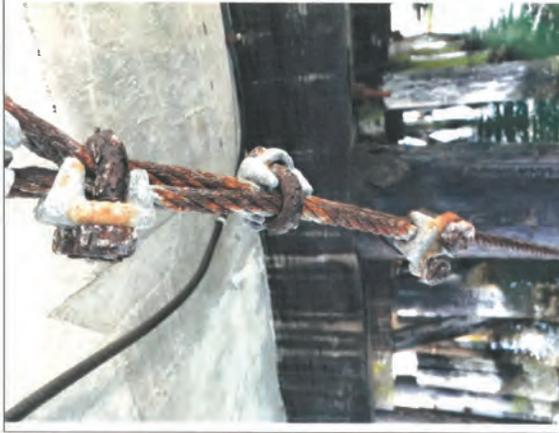
A close-up photograph showing a thick, rusted steel cable secured with a metal fastener on a concrete surface. The background shows a body of water and some industrial structures.	<p>Photo 15 – Close view of Derek crane fastener condition.</p>

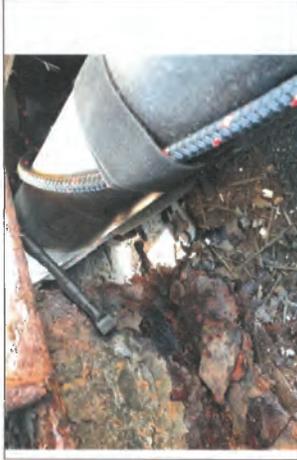
<p>Photo 17 – Close view of structural steel members of the gangway support. Extensive corrosion deterioration noted throughout.</p>

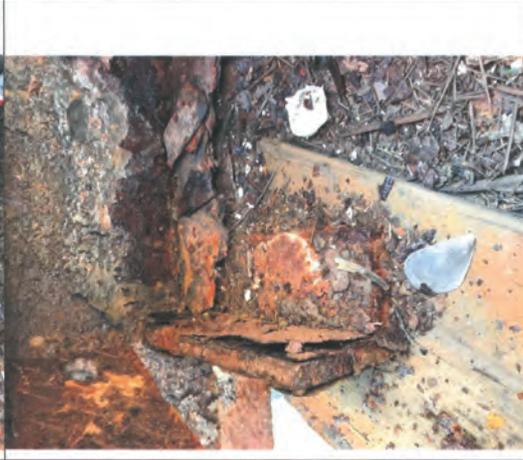
<p>Photo 18 – Close view of structural steel members and fasteners of the gangway support. Extensive corrosion deterioration noted throughout.</p>

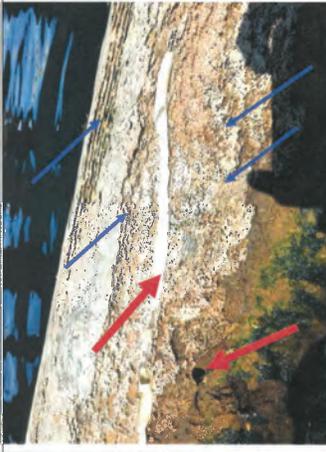
<p>Photo 20 – View of Camel Log on wharf head along gridline 1. Examples of ship worm (red arrows) and Limnoria (blue arrows) deterioration are present.</p>

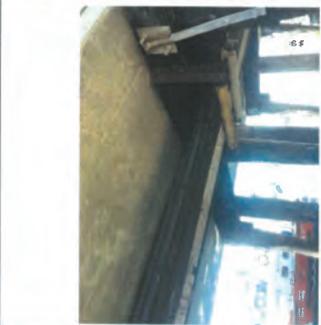
ID	OBSERVATIONS	PICTURES	ACTION REQUIRED	ASSOCIATED WORKS	PRIORITY	CONDITION
G1	<p><b>Commercial Fuel Dock – Fuel Piping</b></p> <p>Fuel piping to commercial fuel dock appears to be in good condition and is assumed to be single wall with trace tech leak detection cable noted.</p>

<p>When pier is replaced, recommend installing new double wall piping with leak detection</p>	<p>None</p>	<p>Short term (1-5 years) Replace</p>	<p>2</p>
G2	<p><b>Fuel Piping Connection at Land</b></p> <p>Fuel piping isolation valves and connections at land appear to be in good condition however do not have leak detection cable.</p>

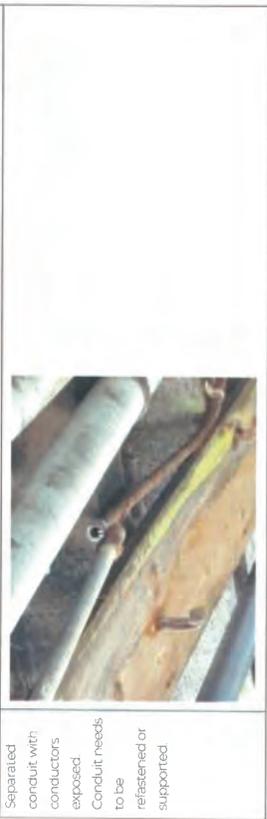
Separated conduit with conductors exposed. Conduit needs to be refastened or supported.

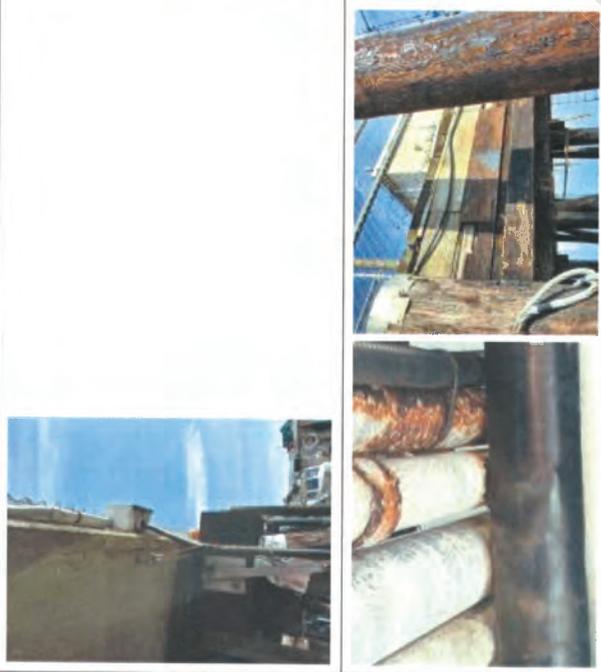
Conduit corrosion on rigid conduits and racking. Note that PVC sheath over the rack has been compromised. Teck cable requiring additional support.
