**Request for Expression of Interest  
(RFEOI) to Develop and Operate a  
Fueling Facility and Commercial Pier at  
the Fisherman's Wharf, Victoria BC.**

**RFEOI # 2020– 28013**

Summary Facility Condition Report 2019 – Huron Pier

## Huron Street Pier Condition Assessment Report

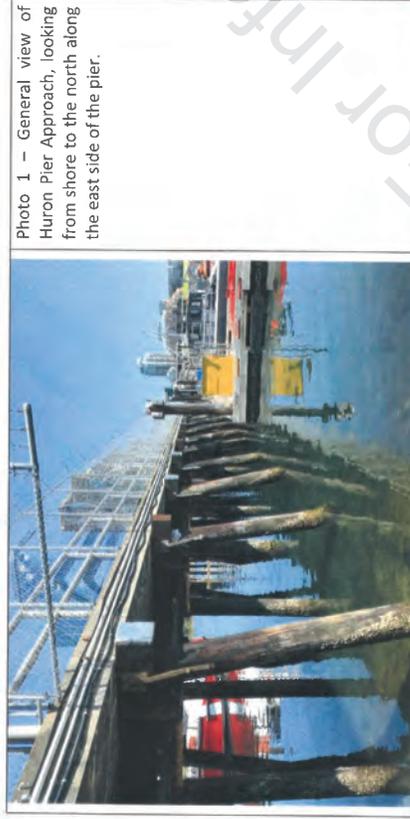
Photo 1 – General view of Huron Pier Approach, looking from shore to the north along the east side of the pier.

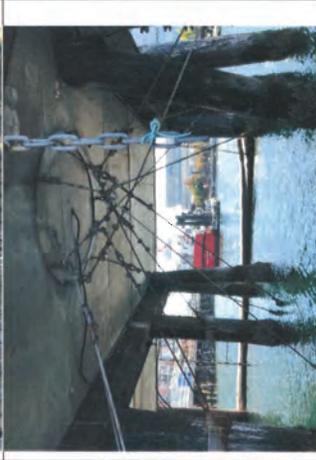
The derrick crane is secured to the deck panels by an unconventional arrangement of steel cables which are secured to the timber piles below (See Photo 14). The cables have suffered corrosion and scaling (See Photo 15) which is now likely compromising the load capacity of the cables. It is recommended that the cable system is replaced with a more conventional support system or the system shall be reviewed by a structural engineer to determine the adequacy of the connections.

<p>Photo 14 – General view of sub-deck support for Derek Crane.</p>

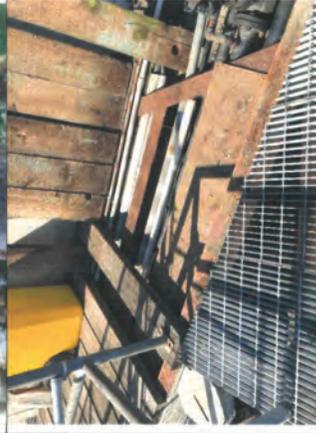
The gangway support frame to access the fuel float is in poor condition. Timber decking was removed to view the steel I-beam members and extensive corrosion and steel section loss was noted throughout. These steel members require replacement. (See Photos 16, 17 & 18)

A photograph showing a wooden gangway ramp structure supported by a metal frame. The structure is made of weathered wood and metal beams, situated outdoors near water.	<p>Photo 16 – General view of the gangway ramp support structure.</p>

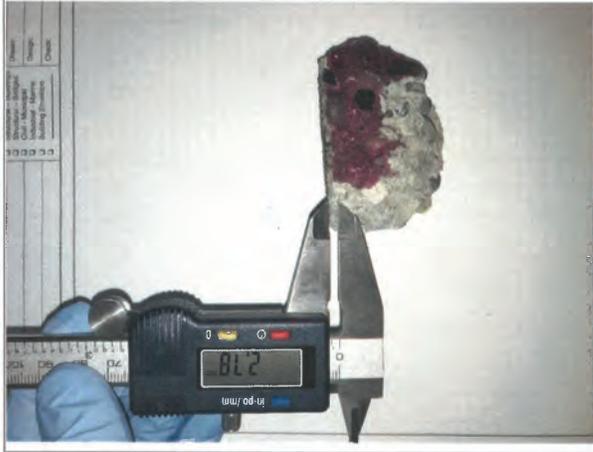
The depth of carbonation measured on the retrieved core was measured to be 2 – 4 mm from the concrete surface (See Photo 19).

<p>Photo 19 – View of concrete core tested for depth of carbonation.</p>

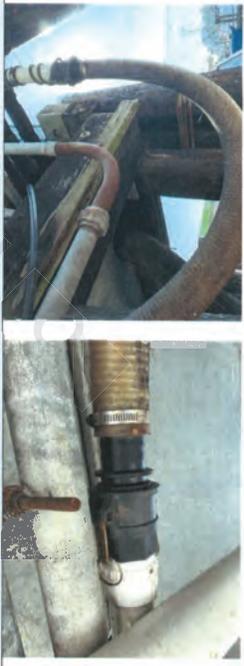
<p>When pier is replaced, recommend installing new double wall piping with leak detection</p>	<p>None</p>	<p>Immediate Inspect</p>	<p>2</p>
G3	<p>Combination of flexible braided hose and rigid plastic PVC fittings/piping. Appears in fair condition.</p>	<p><b>Huron Pier Sanitary Force Main</b></p>

<p>Recommend annual inspection for leaks. Replace in 2 – 5 years.</p>	<p>None</p>	<p>Short term (1-5 years) Replace</p>	<p>3</p>

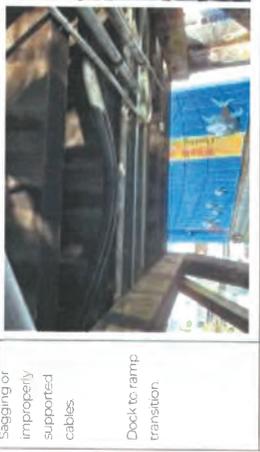
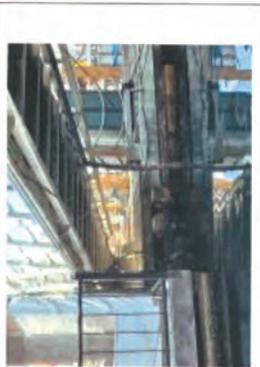
Description	Photo	
Sagging or improperly supported cables

Dock to ramp transition.

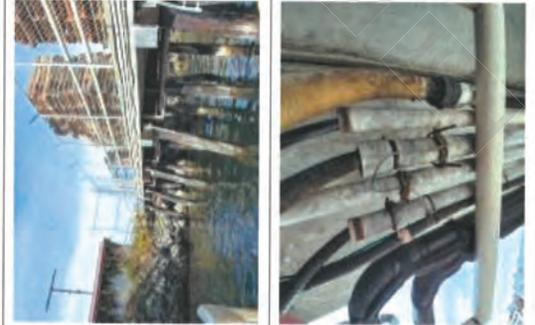
Description	Photo	
Corrosion evident in racking, conduits and couplings.

Spare and abandoned conduits at shore transition.

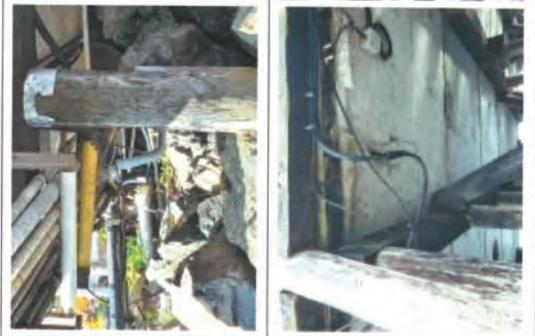
Wiring along the dock supporting small power leads and I dock.
